Stanserhorn, Stans (NW), February 24 2012 – Excavator driver buried by full depth snowslide while clearing snow.¹

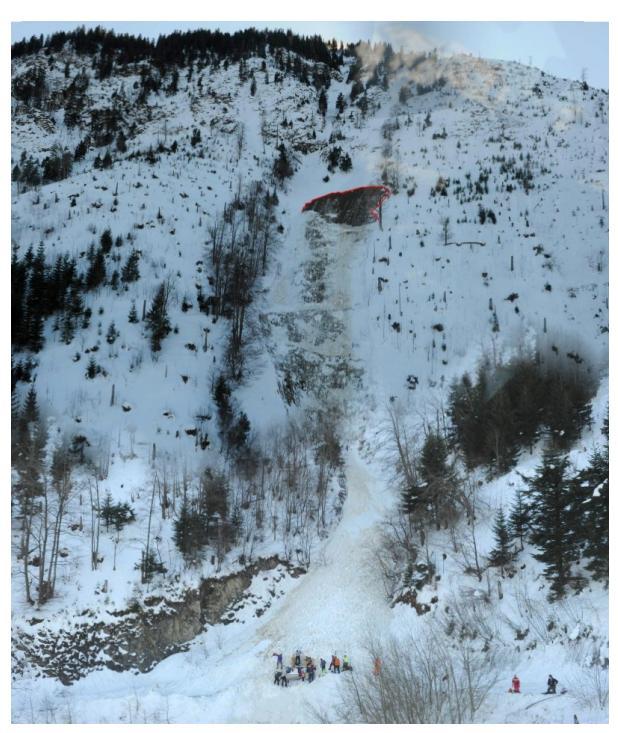
FIGURE 1 – Rescuers uncovering the snow clearing vehicle on the forest road to Bluematt on the Stanserhorn in canton Nidwalden (February 24 2012, photo: Nidwalden cantonal police).

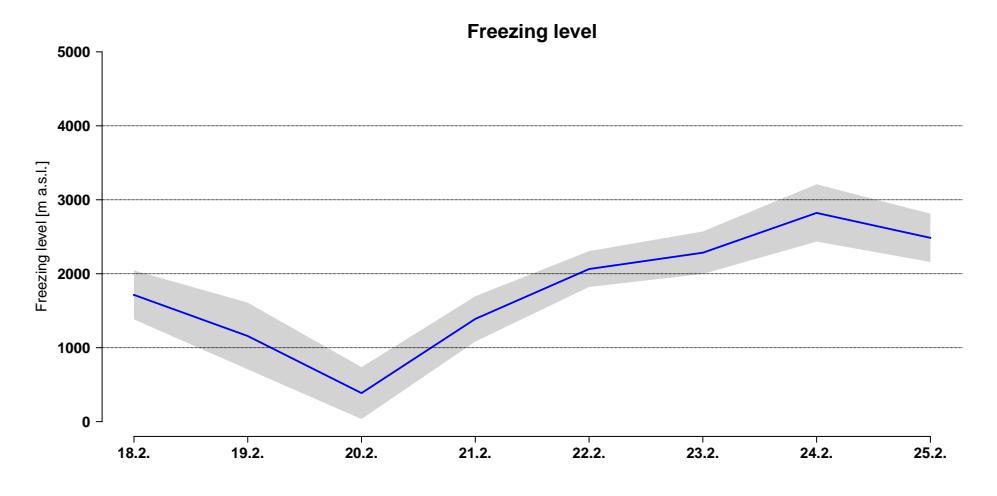
FIGURE 2 – Change in zero-degree level between February 18 and 24 2012. On February 24 the zero-degree level rose to 2400 m and then to 3200 m. The zero-degree level was calculated from data collected by 11 automated ENET measuring stations distributed throughout the entire Swiss Alps assuming a temperature drop of 0.6 degrees per 100 m altitude (mean: blue line, grey area: dispersion of values recorded by the 11 stations).

There had been no precipitation on the three days preceding the accident. The zero-degree level was rising significantly in altitude, from approximately 500 m on February 20 to approximately 2700 m on February 24 (Fig. 2). On the night before the accident the skies were clear. The profile taken on a north facing slope the day after the accident indicated a partly moist snowpack (Fig. 3).

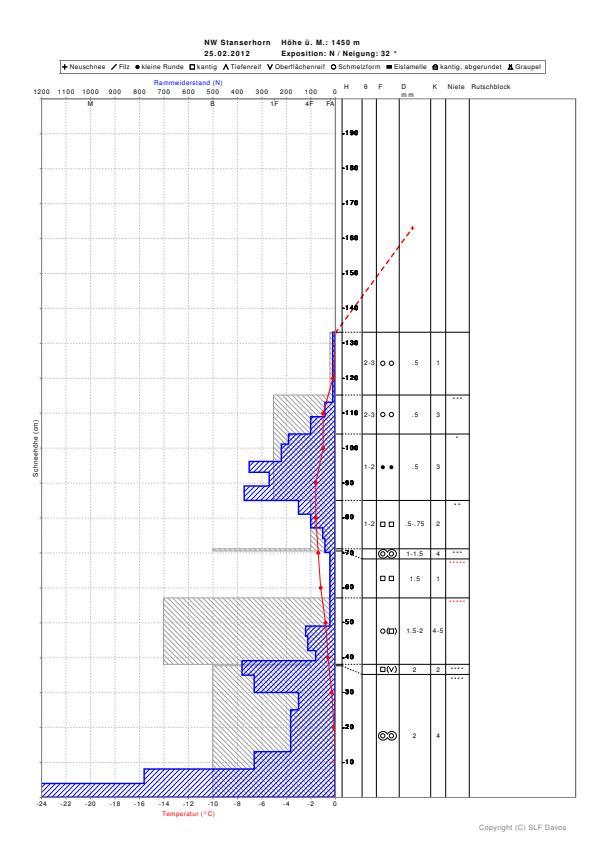
FIGURE 3 – Snow profile taken at 1450 m on a north facing slope the day after the accident. For safety reasons, it was taken on an adjacent slope in a similar aspect, but at an altitude approximately 200 metres higher. At the profile site the snowpack was still dry to some extent, but to some extent already moist.

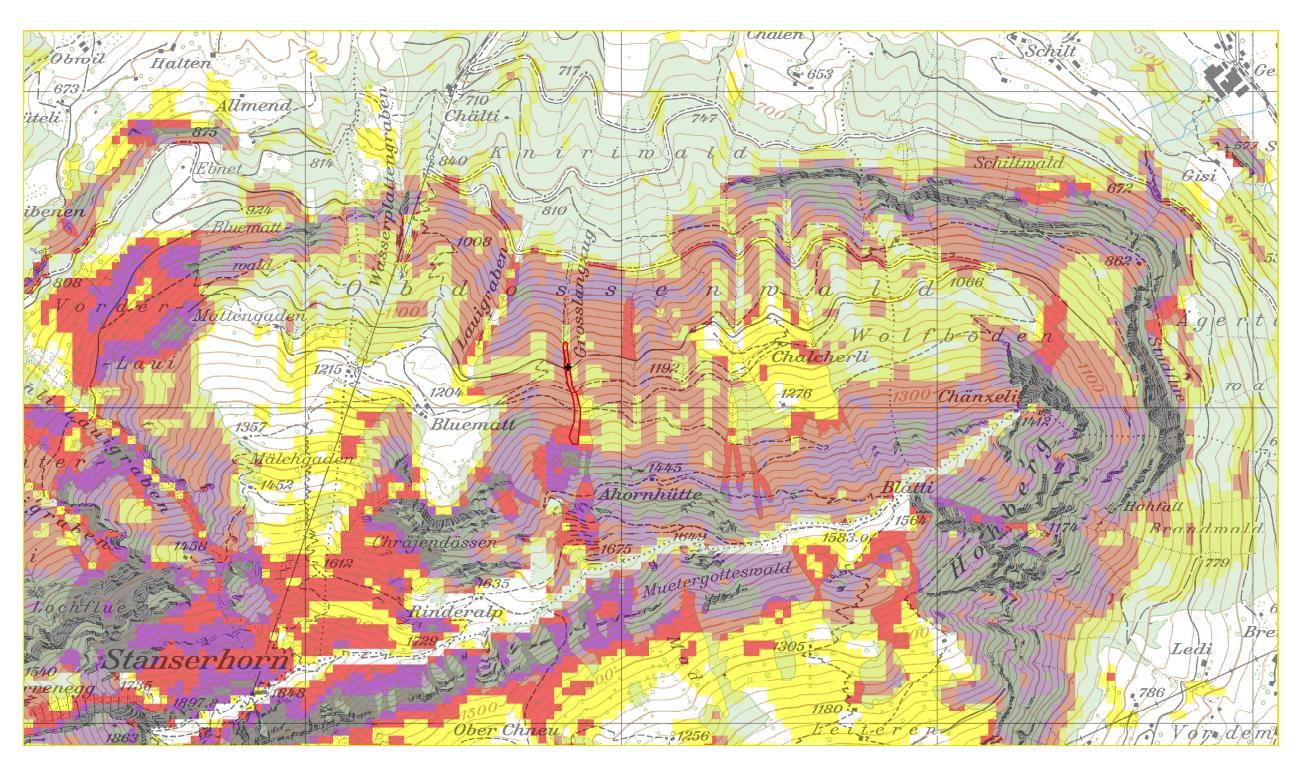
FIGURE 4 – Map section of accident site (1:25,000, national map sheet 1170) showing the outline of the avalanche (red) and the place where the victim was found (black cross). Map reproduced with permission from swisstopo (JA100118/JD100040).
